Manhole Inspection Summary

Manhole # S37WW_026MH

Insp Date: **1/10/07 9:19 AM**

Location Address: **611 30TH ST**

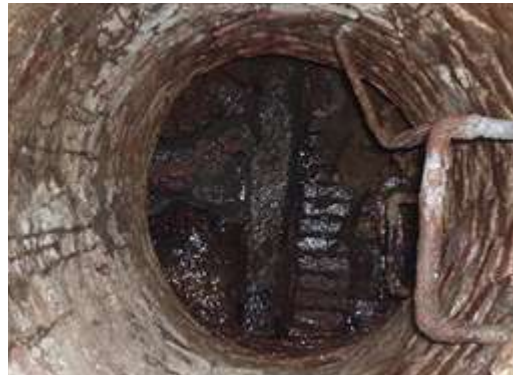
Top View

☒ **Debris** (not Condition related)

Count: **4** Missing: **0** ☒ **Corroded**

Corroded steps. Bench debris.

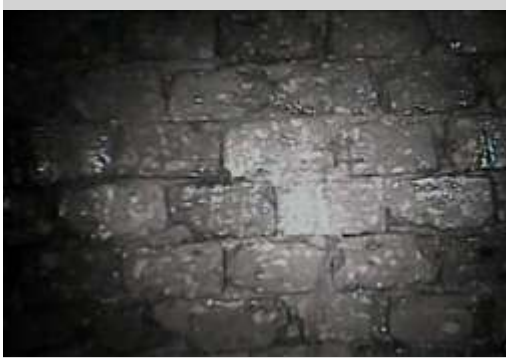
Defect

Infiltration: ☐ None ☐ Joint ☐ Cracks ☐ Mortar ☐ Roots ☒ **Wall**

Barrel infiltration.

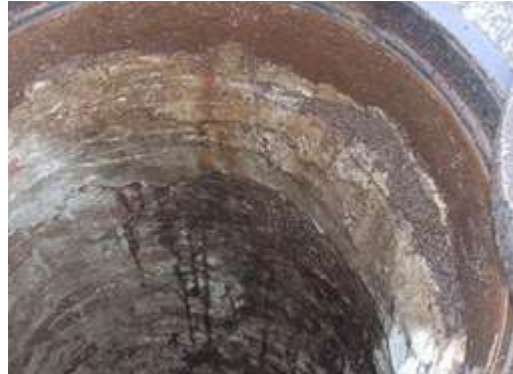
Defect

☒ **Leaks**

Infiltration: ☐ None ☒ **Joint** ☐ Cracks ☐ Mortar ☐ Roots ☒ **Wall**

Infiltration: ☐ None ☐ Joint ☐ Cracks ☐ Mortar ☐ Roots ☒ **Wall**

Frame leaks. Adjustment and Corbel infiltration.
